Romanian Messerschmitt Bf 109E camouflage and markings

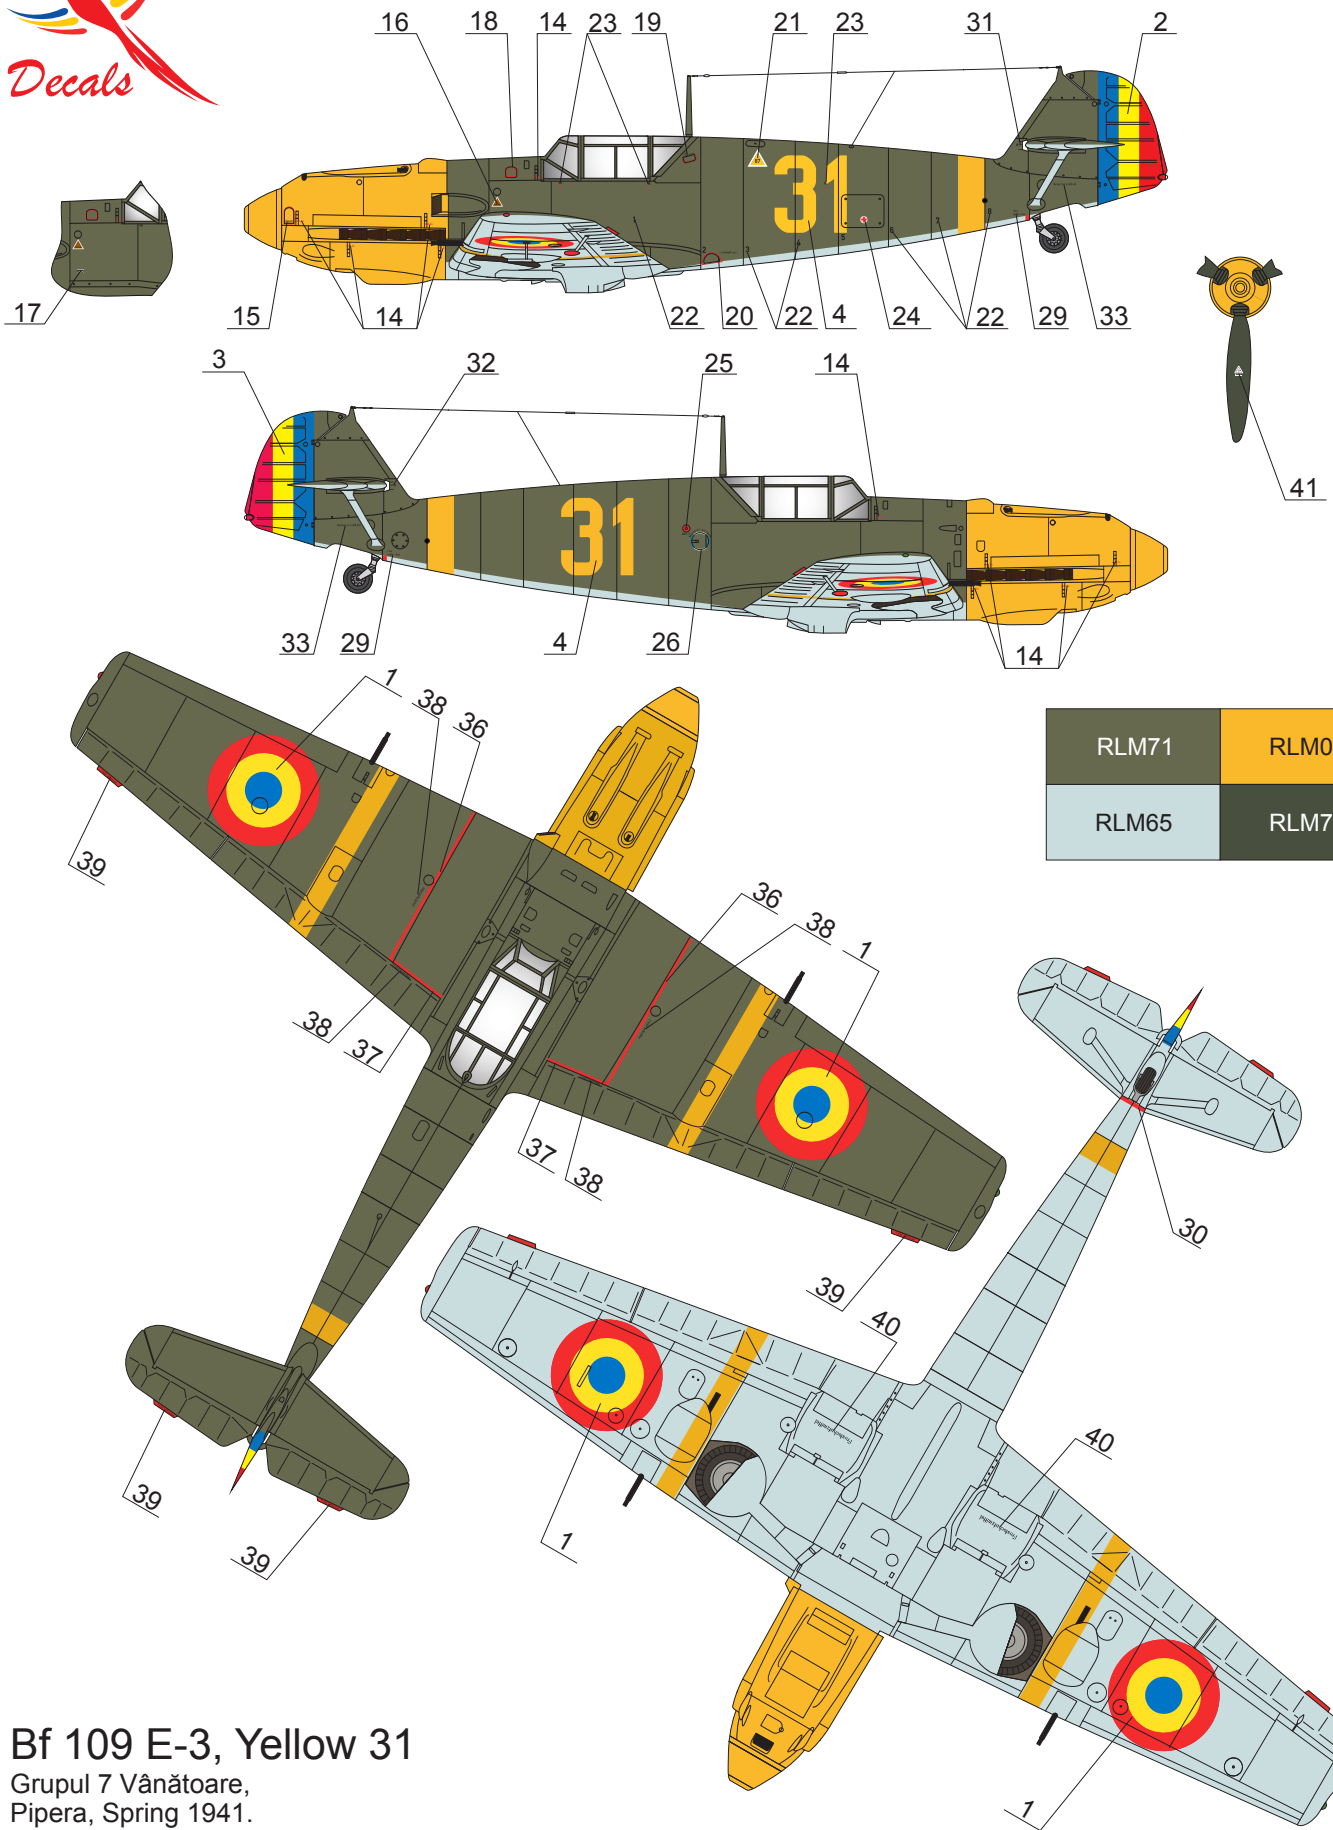
Bf 109 E-3, Yellow 31
 Grupul 7 Vânătoare,
 Pipera, Spring 1941.

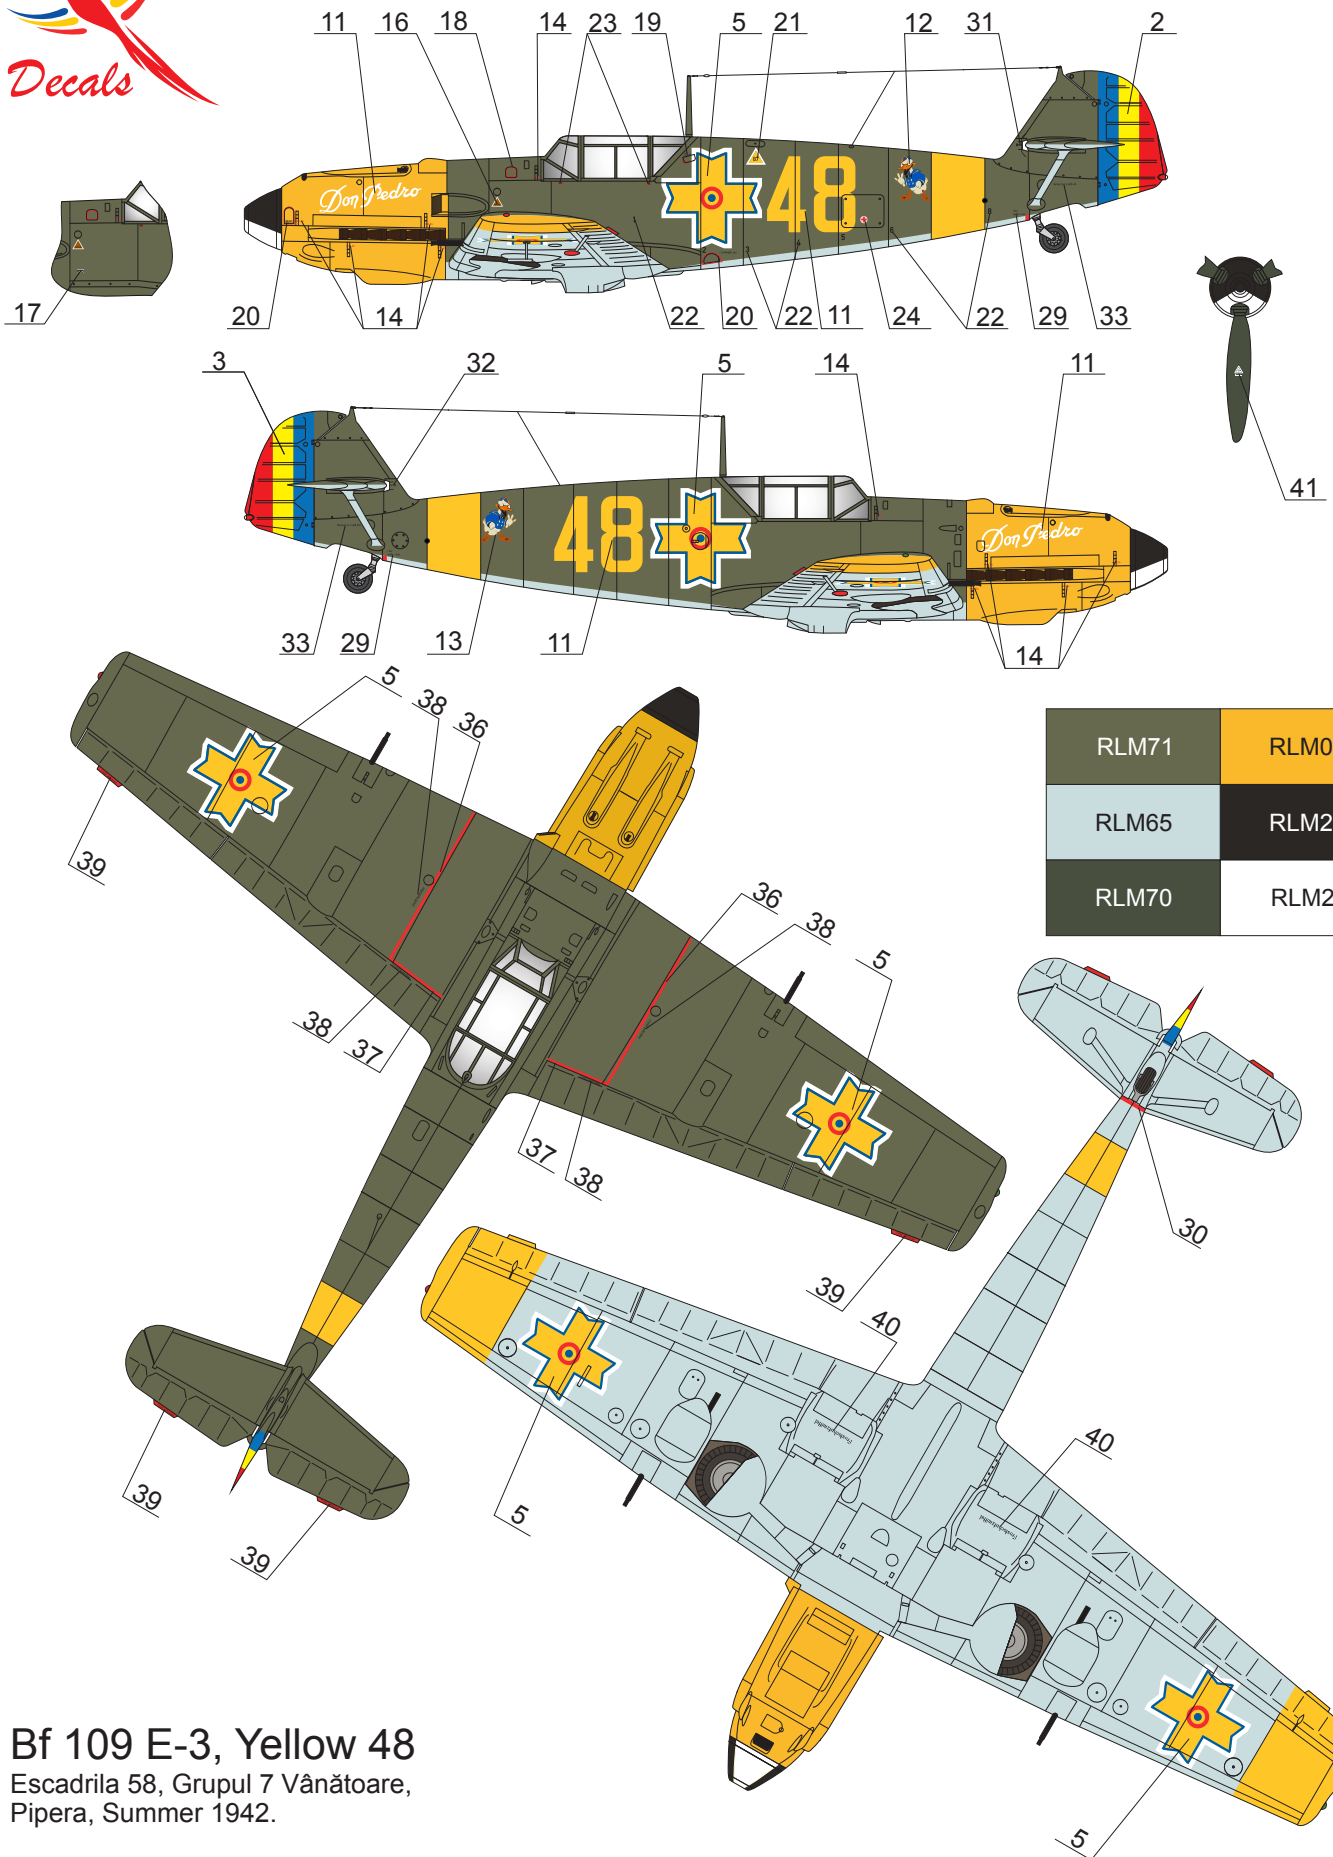
Bf 109 E-3, Yellow 48
Escadrila 58, Grupul 7 Vânătoare,
Pipera, Summer 1942.

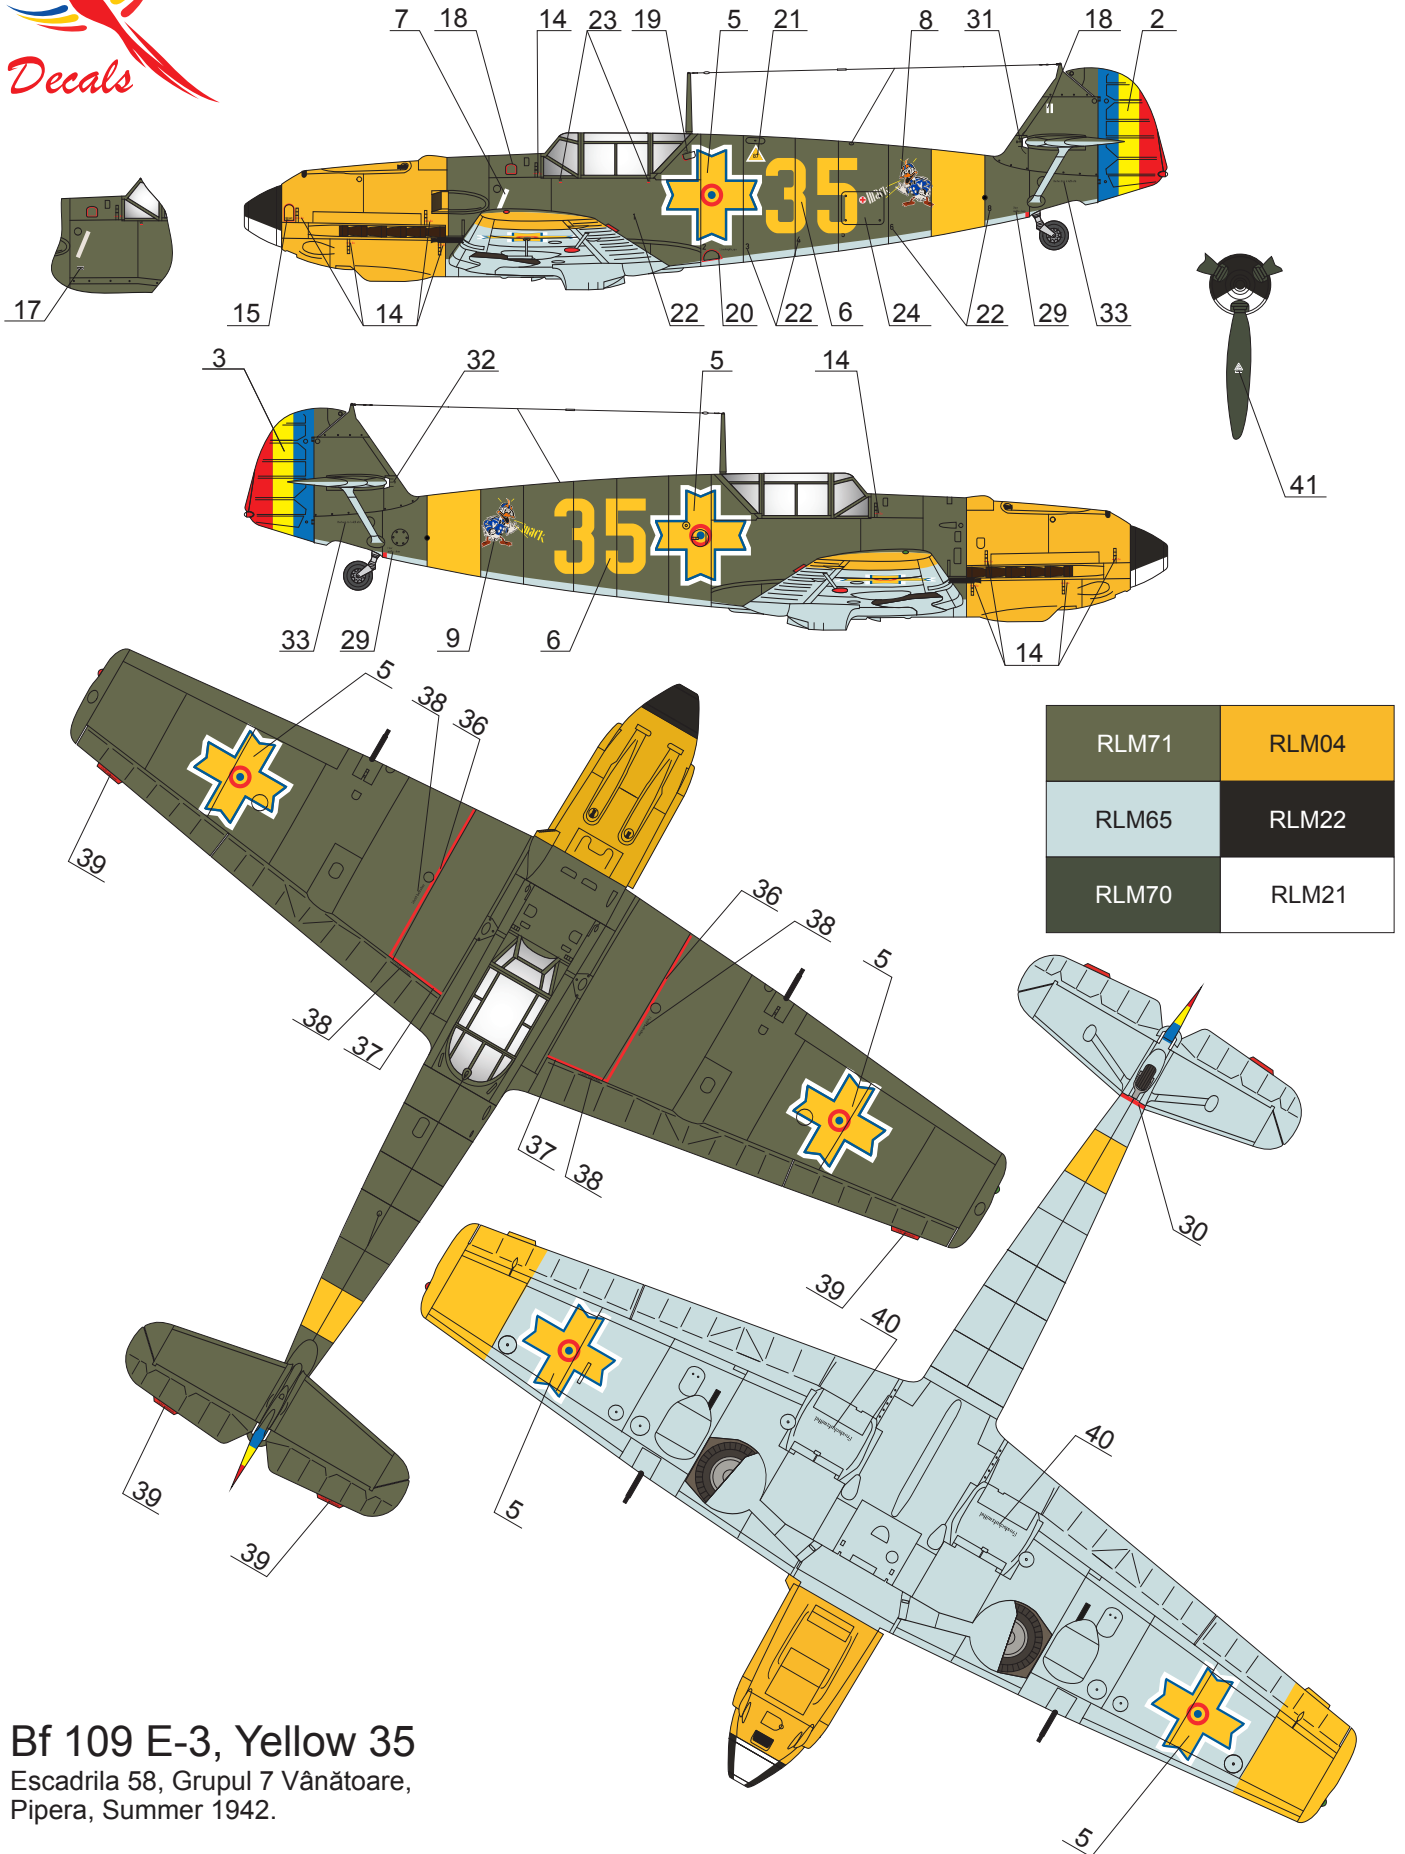
Bf 109 E-3, Yellow 35
Escadrila 58, Grupul 7 Vânătoare,
Pipera, Summer 1942.
