Romanian Messerschmitt Bf 109E camouflage and markings

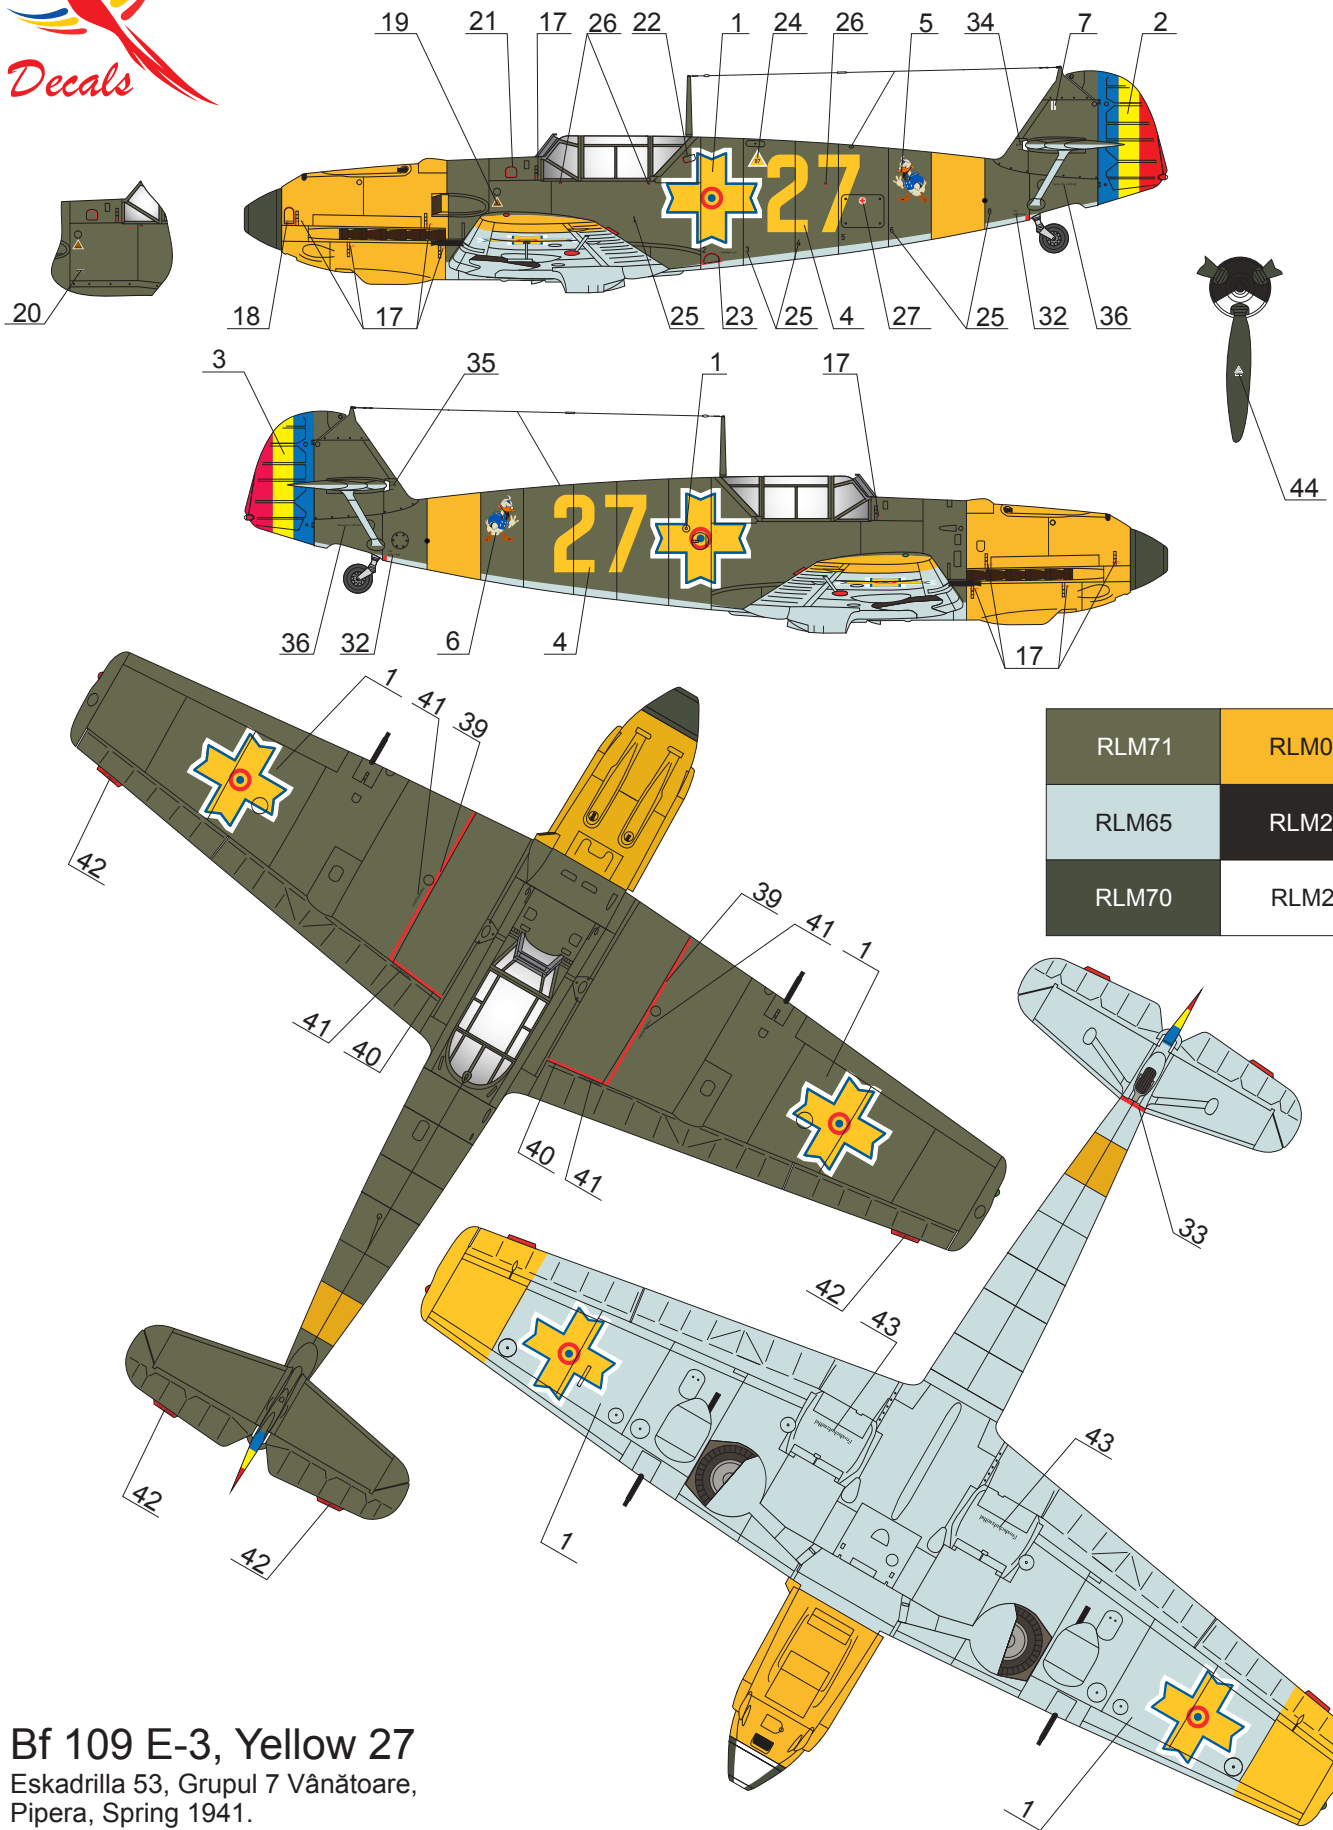
Bf 109 E-3, Yellow 27
Eskadrilla 53, Grupul 7 Vânătoare,
Pipera, Spring 1941.
